Elevation is Not Enough: Utilizing Smart Building Practices

Full Mitigation Best Practice Story

Saint Tammany Parish, Louisiana

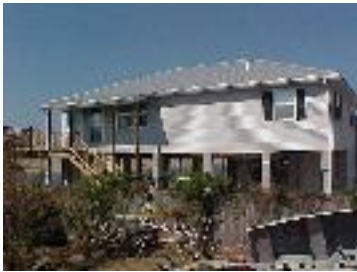
Everett and Carol Brugier's elevated home, with hurricane debris in the foreground.

After obtaining a building permit, the Brugiers built their home with the assistance of a contractor from nearby Lacombe. “He knows his stuff and knows how to build well,” said Mr. Brugier. The local building code requires homes in Pirates Cove to be elevated to 13 feet above sea level, which is four feet above the Base Flood Elevation, the average floodwater depth for a 100-year flood event. The Brugiers chose to elevate their home to 16.4 feet, which provided enough height to park their motor home underneath the house. The additional height prevented several feet of water from reaching into their living level during the 2005 hurricane season.

The incorporation of hurricane-resistant features (beyond the basic elevation of the structure) into the Brugiers’ house increased construction costs by an estimated \$12,000, but they consider it a worthwhile investment, especially after the 2005 hurricane season. Although the floodwaters beneath their home rose to 15 feet, within about one and a half feet of the floor joists, the breakaway walls survived intact, no water entered the home, and the roof was not damaged. Damage was limited to the loss of the gutters on the northeast side of the house and to the air-conditioning unit, which was above the floodwater but not securely fastened to its platform.

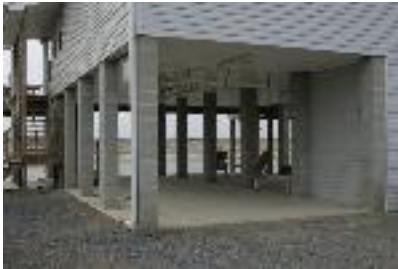
Concrete column supports beneath the Brugiers' elevated home.

The Brugiers’ house incorporated several hurricane-resistant features. The house was supported on reinforced concrete block columns. The reinforcement was embedded 24 inches into the structural slab, and extended the full height of the column. Horizontal wooden beams consisting of two-inch by 12-inch members rested on top of the columns and provided the framework for support. The walls of the house were framed with two-inch by two-inch members. The foundation-to-floor and wall-to-roof connections were strengthened with hurricane clips, which are designed to maintain the integrity of the connection during very high winds. Windows, whose style and placement are also critical to preventing hurricane damage, also met the parish’s building code requirements. Another feature of the Brugiers’ house was breakaway walls, which are designed to disconnect from the house in the event of storm surge. These breakaway walls not only mitigate further damage, but can also be designed to be aesthetically pleasing elements of a house. The Brugiers moved into their new home in November 2004.
